URGENT MEDICAL DEVICE SAFETY NOTICE

RE: **OLYMPUS Uretero-reno Fiberscope**
Models: URF-P6, URF-P6R
Serial numbers: all serial numbers

Instructions for safe use

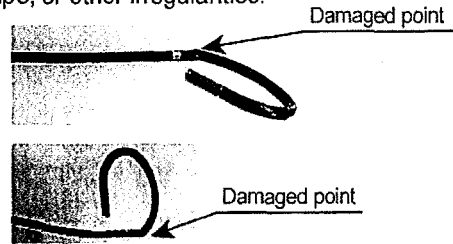
3. Visually inspect the bending section for abnormal bending shape, or other irregularities.

Not OK

If any irregularity is observed during the inspection described in Chapter 3 of the Instruction Manual, "Preparation and Inspection", do not use the endoscope and solve the problem as described in Section 5.2, "Troubleshooting guide". If the problem still cannot be resolved, send the endoscope to Olympus for repair as described in Section 5.4, "Returning the endoscope for repair". Also, should any irregularity be observed while using the endoscope, stop using it immediately and withdraw the endoscope from the patient as described Section 5.3, "Withdrawal of the endoscope with an irregularity".
