Urgent Field Safety Notice

220-240V Unit Cable (power cord) for Infusomat fmS, Infusomat P and SpaceCover

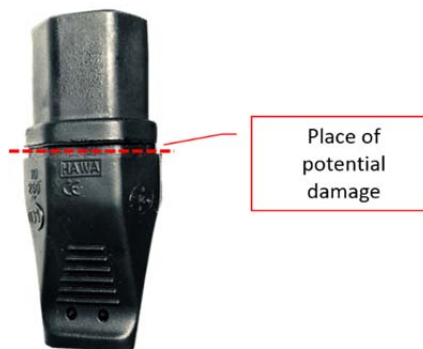
In the course of Post Market Surveillance Activities we discovered that the above specified power cords might get damaged at the device connector. In very rare cases, the device connector might break if heavy lateral force is applied (see figure 1). If exposed electrical contacts are touched the user might be opposed to the potential risk of an electrical shock.

Figure 1 Place of potential damage

- Confirm the receipt of this information.
- Inform the responsible personnel in the affected areas of your facility. If you are a distributor please forward this FSCA to affected customers.
- Remind all users of good practice with electrical equipment.
- We recommend to identify affected power cords in your hospital and replace them. Take broken power cords out of service immediately.
- Please contact your local sales representative to receive free replacements for affected power cords
- If you wish to continue to use affected power cords, please avoid improper handling such as heavy lateral force under all circumstances.
